Research Development and Technology

Missouri
Department
of Transportation

Slope Stabilization with Recycled Plastic Pins

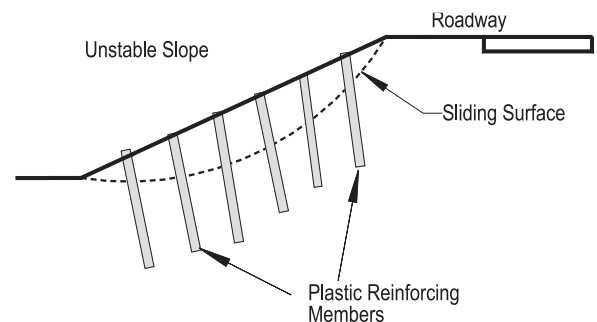
Figure 1. Stabilization of slope using recycled plastic reinforcement.

A new technique for stabilizing surficial slides in earth slopes and embankments has been developed for the Missouri Department of Transportation by investigators from the University of Missouri-Columbia. The technique uses reinforcing members, manufactured from recycled plastics and other by-products, to intercept potential shallow sliding surfaces and provide additional resistance to maintain the stability of the slope (Figure 1). The general feasibility of the technique was demonstrated previously at a “proof of concept” site located on Interstate 70 near Emma, Missouri.

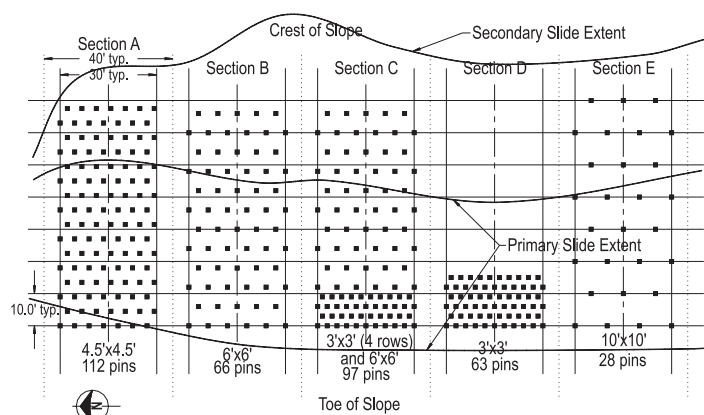
Figure 2. Plan view of US54-Fulton test site showing alternative stabilization schemes utilized at the site

bilization schemes were used at different sites, and within single sites (Figure 2), so that the technique could be optimized based on the costs and performance of each stabilized section. Stabilization schemes varied from schemes with

closely spaced members (e.g. 3-ft by 3-ft uniform grid) that are very likely to be effective to schemes with relatively widely spaced members (e.g. 10-ft by 10-ft) that are not likely to provide long-term stabilization.

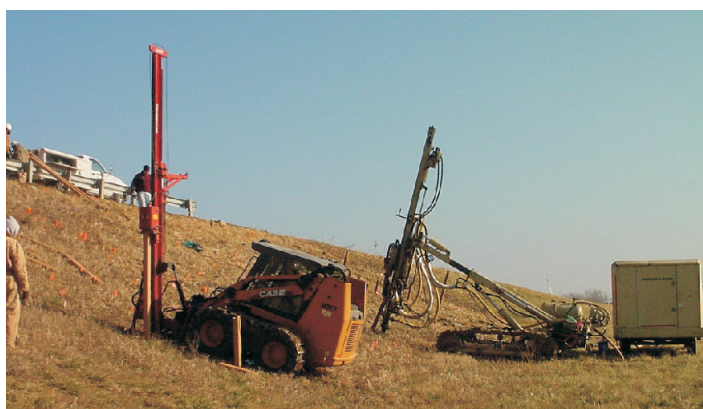
Figure 3. Equipment used for installation of recycled plastic reinforcing members.

Reinforcing members were installed using two different types of equipment (Figure 3). The vast majority of members were installed using a crawler-mounted pneumatic rock drill; however, a select number of members were installed using a simple drop-weight hammer mounted on a skid steer loader. Both types of equipment proved to be

extremely effective for driving the reinforcing members. Installation rates generally averaged approximately 100 members per day for each type of equipment and peak installation rates exceeded 140 members per day. Installation at the I435-Kansas City sites was completed in December 2001; installation at the US36-Stewartsville site was completed in May 2002 and installations at the I70-Emma (Phase II) and the US54-Fulton sites were completed in January 2003. Following installation, each of the sites was

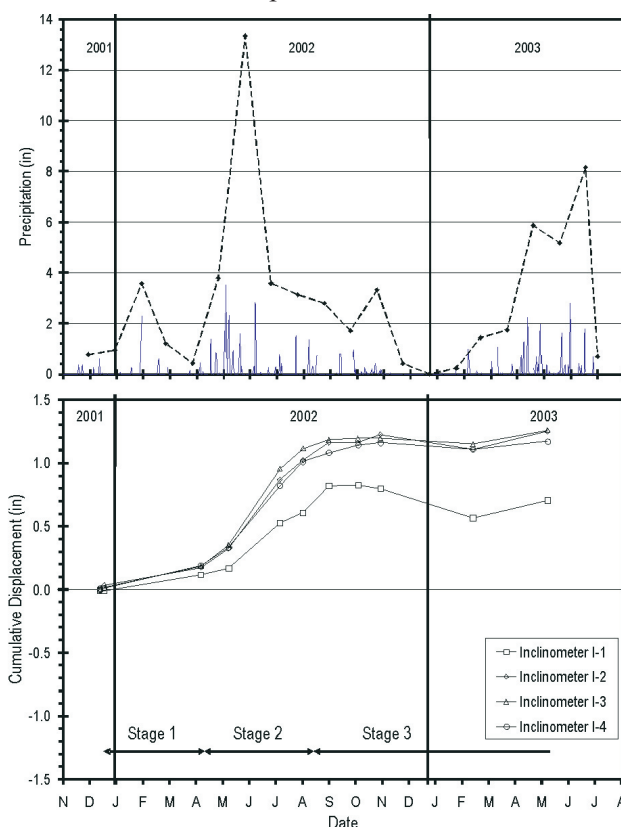
Figure 4. Precipitation and lateral deflections at I435-Wornall Road test site.

To date, no failures have been observed in any of the test sections and all test sections continue to perform well, although test sections at the US36-Stewartsville, I70-Emma (Phase II), and US54-Fulton sites have yet to be subjected to conditions that are believed to have led to prior failure of the slopes. The behavior observed at each site has generally followed a consistent, three stage pattern of behavior (Figure 4). In the first stage, the slopes are observed to experience little movement as a result of favorable precipitation conditions at the site. In Stage 2, additional movement is observed to occur in response to additional precipitation at the site as the resistance in the reinforcing members is mobilized. The slopes are then observed to enter Stage 3, wherein movements in the slopes are observed to cease due to an equilibrium condition being reached as sufficient resistance is mobilized to maintain the stability of the slope. Slopes at the I435-Kansas City sites and the I70-Emma (Phase I) site have exhibited all three of these stages of behavior, while slopes at the remaining sites remain in either Stage 1 or Stage 2. Additional monitoring of these sites is ongoing to establish whether the stabilization schemes established at these sites are sufficient to provide long-term stabilization of the slopes.
